CASE STUDY

Client: Tenterden Town Council
Location: Tenterden Recreation Ground
Product(s): TURFPROTECTA mesh
Application: Recreation Ground Reinforcement

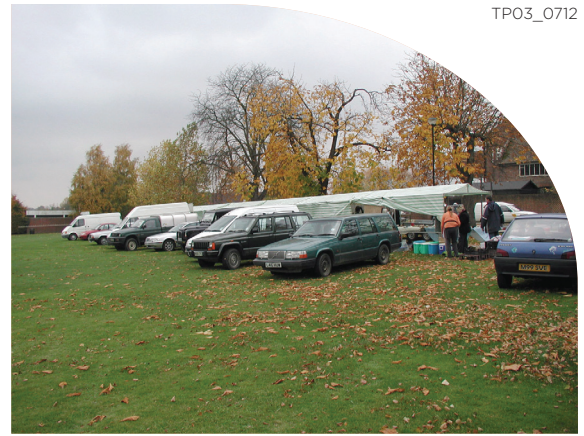
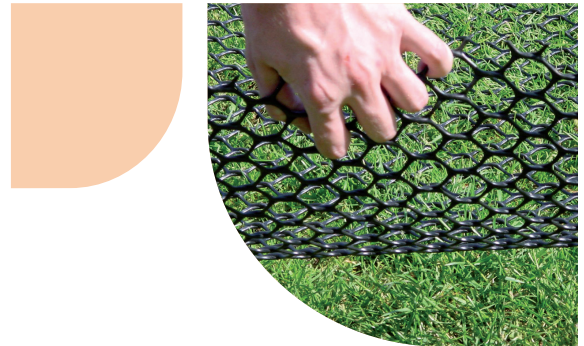
TURFPROTECTA reinforcement mesh was used to lay directly onto the existing grassed area. The plastic mesh was pinned using metal U-pins every 3.28' to hold the mesh down. Each roll of mesh was overlapped to ensure maximum coverage. A covering of top soil was spread over the mesh to fill in any uneven areas and to encourage the grass to grow through the mesh filaments quickly. The area was fenced off for a few weeks, and then mown as normal. Within a few months the mesh had completely disappeared under the surface as the grass roots interlocked with the mesh filaments, ensuring a stable reinforced grassed area clear of rutting.

TURFPROTECTA mesh was easy to install onto the existing grass surface and allowed the grass to quickly grow through the mesh apertures. This created a strong interlock with the root mass and ensured the area could be used for the weekly market vehicles and pedestrians without damaging or rutting the grass surface.
